Polallie Creek Debris Flow and Subsequent Dam-Break Flood of 1980, East Fork Hood River Basin, Oregon

United States
Geological
Survey
Water-Supply
Paper 2273

By GARY L. GALLINO and THOMAS C. PIERSON

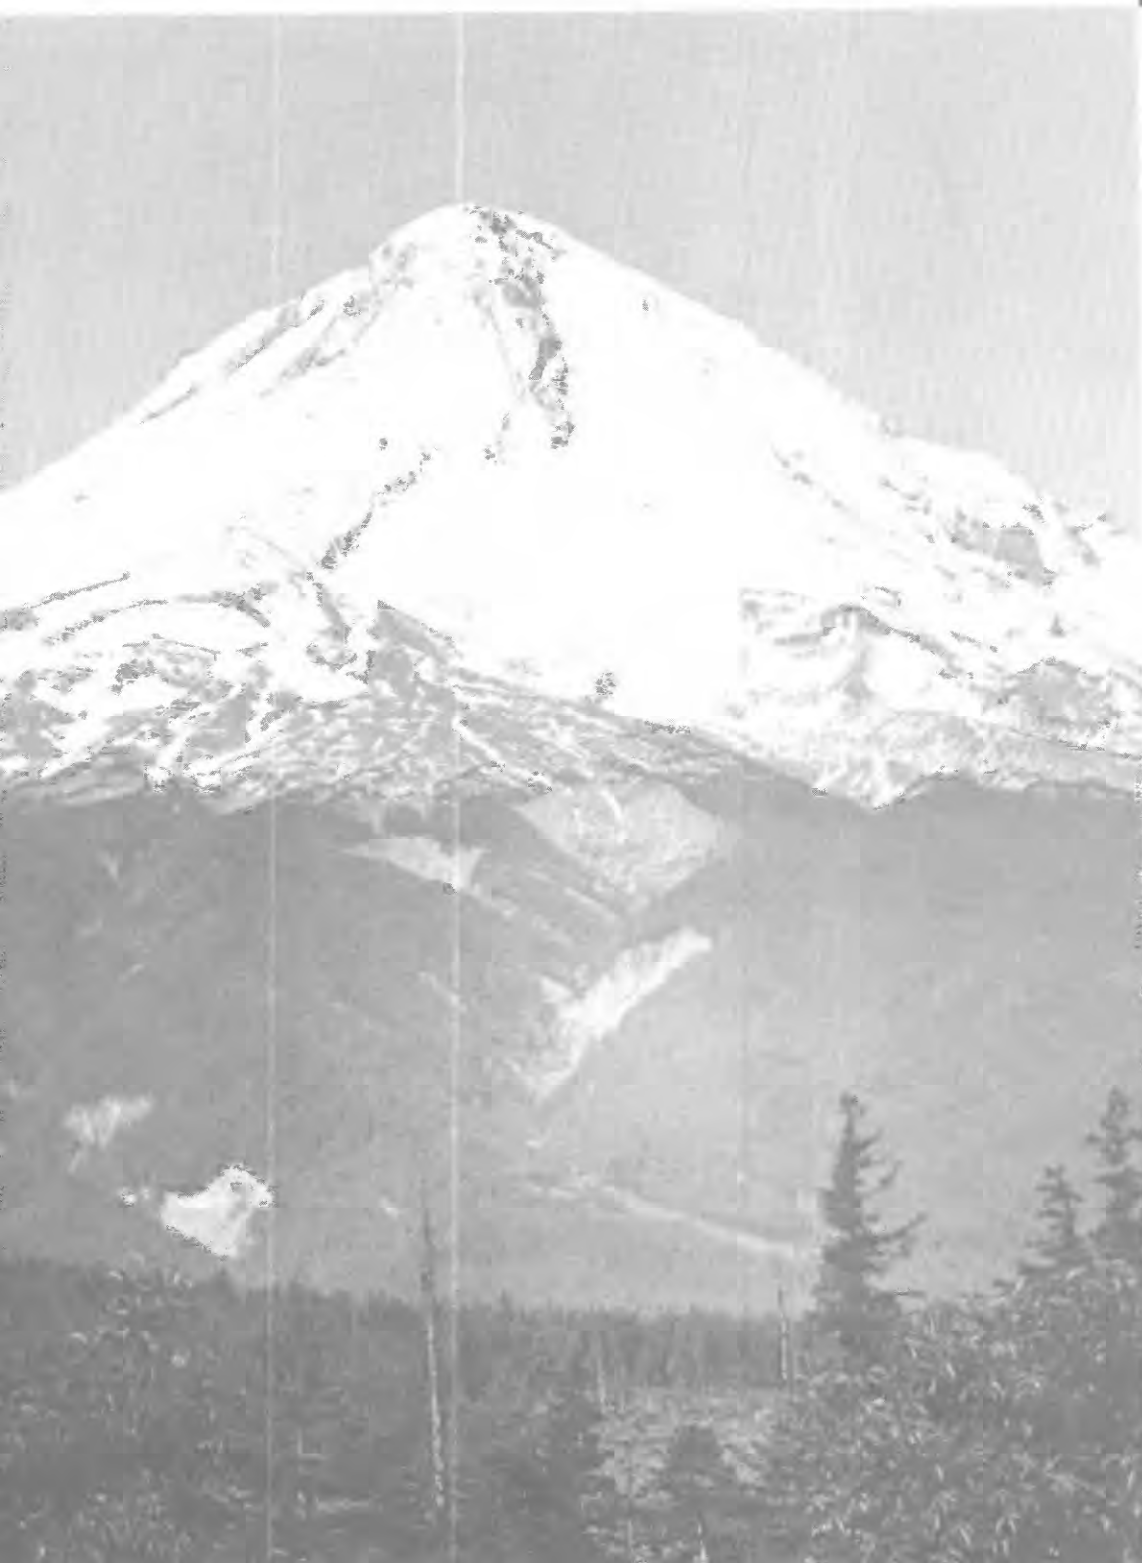
Aerial view southwestward up Polallie Creek to Mount Hood. Confluence with the East Fork Hood River visible at lower center. Photograph courtesy of U.S. Forest Service, Mount Hood National Forest, 1971 (L20805-105).

Aerial photograph showing view up Polallie Creek to Mount Hood.

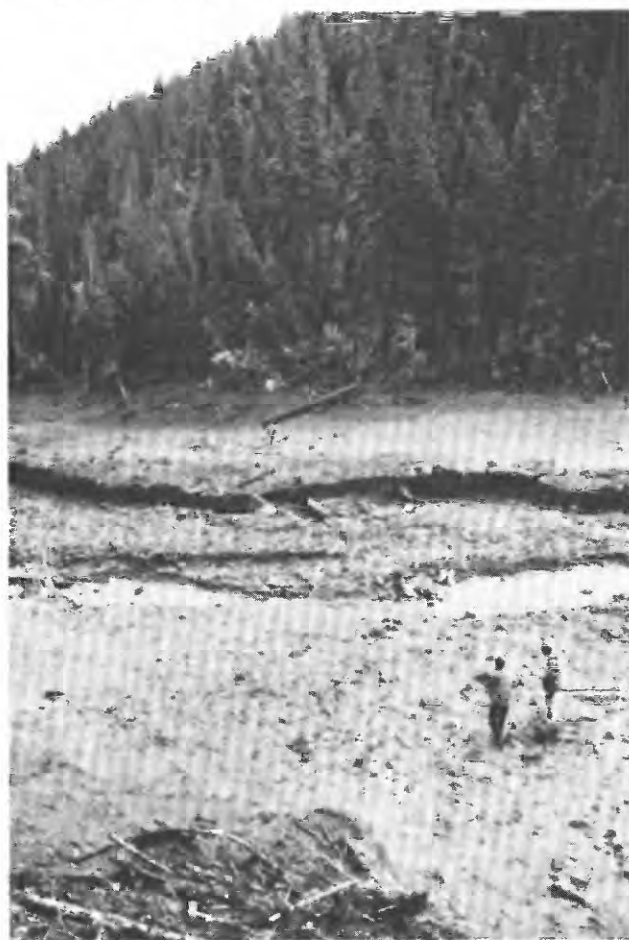
Figure 5. Debris-flow-impacted channel in lower Polallie Creek 1.2 mi upstream from mouth (slope-area reach). Photograph taken January 7, 1981.

Field observations following the flow event on December 25, 1980, confirmed that a large debris flow and not a water flood had occurred in Polallie Creek. An anomalously large discharge (table 3) from a small watershed was the first indication of a debris flow. Furthermore, (1) the channel had been scoured of essentially all vegetation along the flow path (fig. 5); (2) unsorted and

unstratified deposits lined the channel and dried gravelly mud (like dry concrete) coated branches and logs at the flow margin; and (3) marginal levees composed of boulders and logs (fig. 6) had formed in a number of locations. Richard Ragan (U.S. Forest Service) described the massive, unsorted, bouldery deposit at the mouth of Polallie Creek as "resembling wet concrete" on the morning of December 26. The fact that the East Fork Hood River, flowing at an estimated 5,000 ft³/s at the time, had been temporarily dammed by debris, emphasizes the catastrophic nature of the debris deposition.

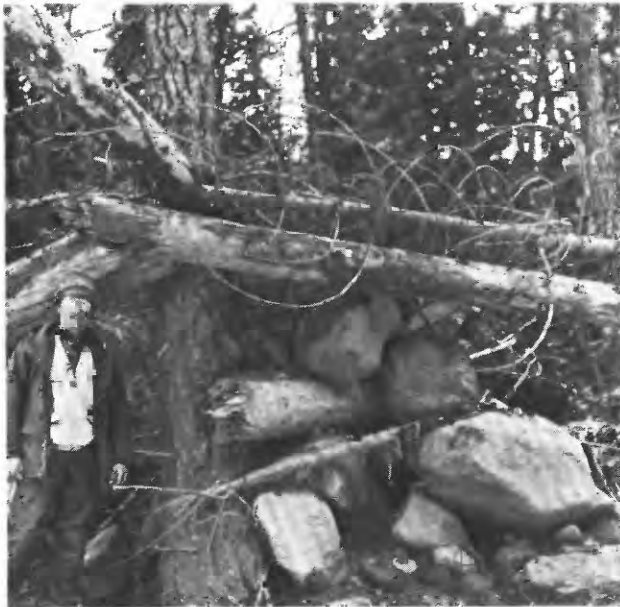
Figure 6. Lateral levee of coarse rock debris and logs left by debris flow, lower Polallie Creek. Photograph taken April 28, 1981.

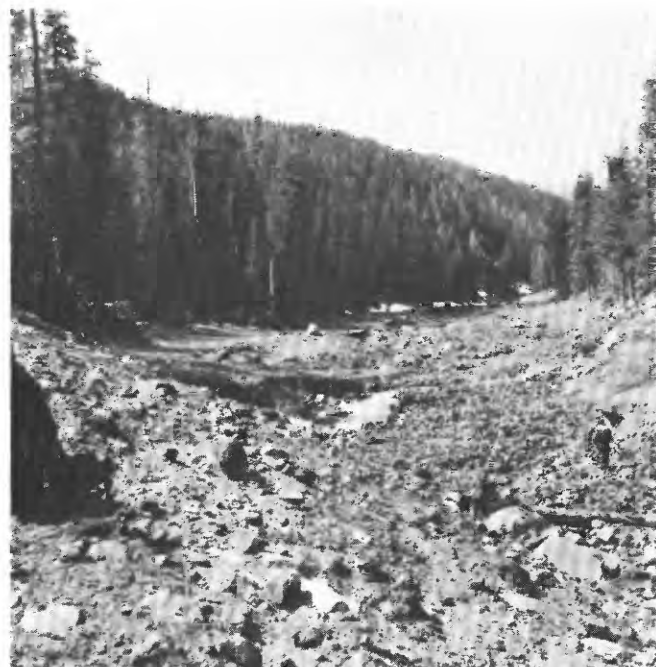
Figure 8. View upstream through the slope-area reach, lower Polallie Creek. Photograph taken April 28, 1981, from bank over-ridden by the debris flow.

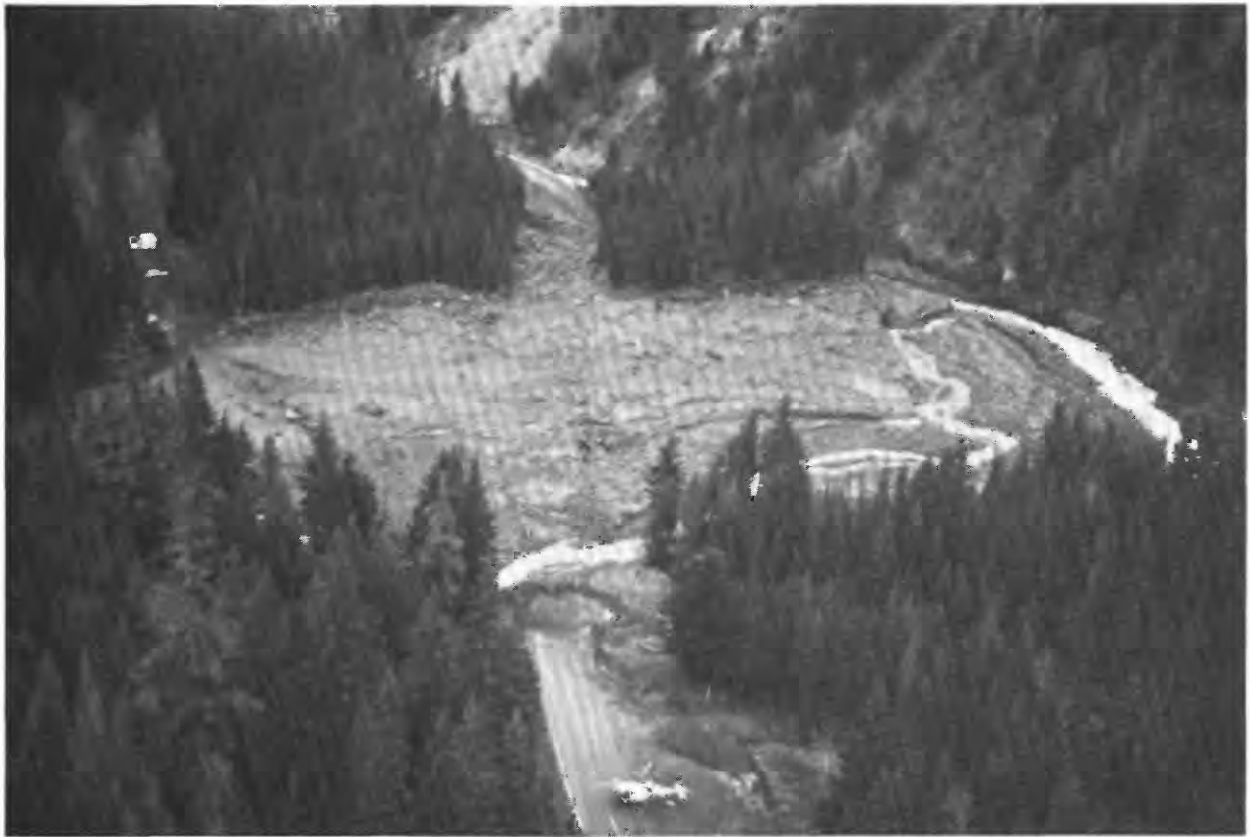
Figure 13. Aerial view of the debris-flow-covered fan at the mouth of Polallie Creek, less than 24 hours after the debris flow had occurred. Outlet channel of the flood through the debris blockage is at the far right center. Photograph courtesy of U.S. Forest Service, December 26, 1980.

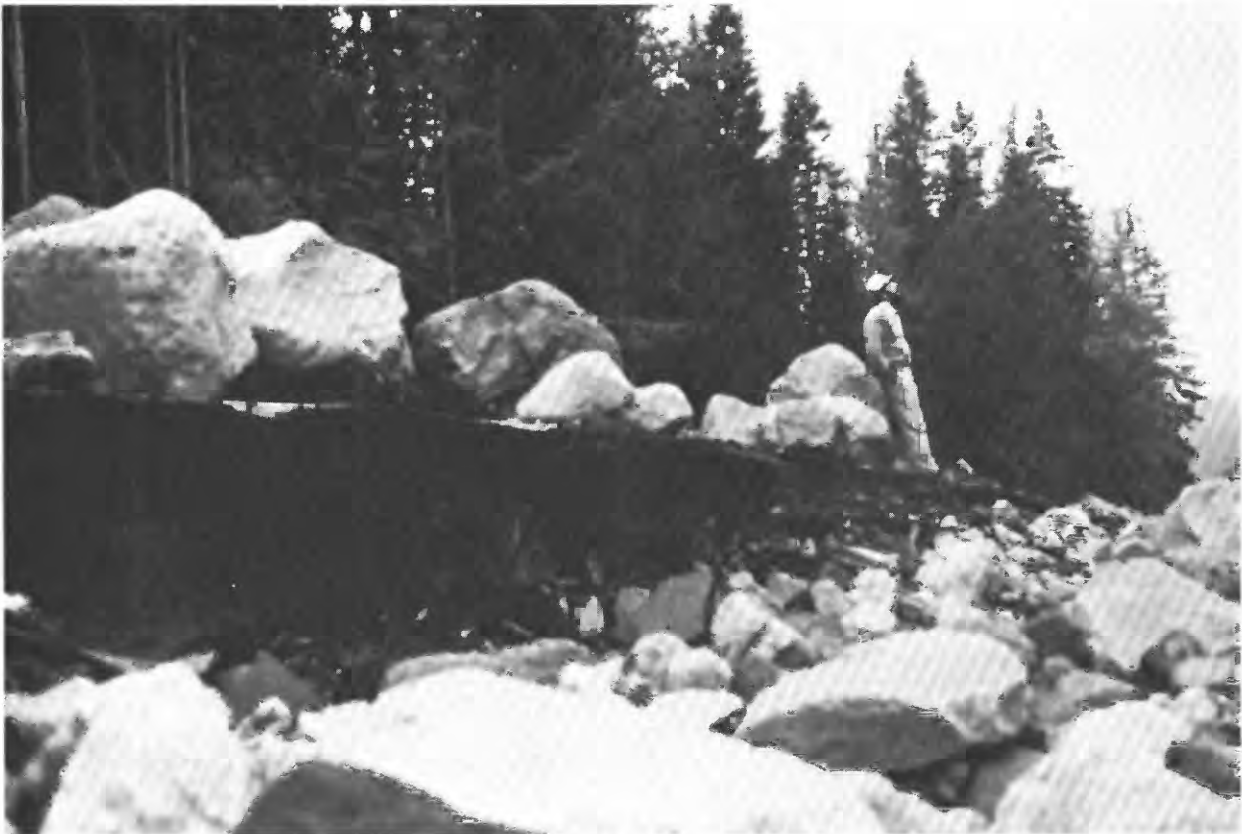
Figure 14. Flood-deposited boulders strewn on surface of State Highway 35 about 3.5 miles downstream from the mouth of Polallie Creek. Photograph courtesy of U.S. Forest Service, December 26, 1980.

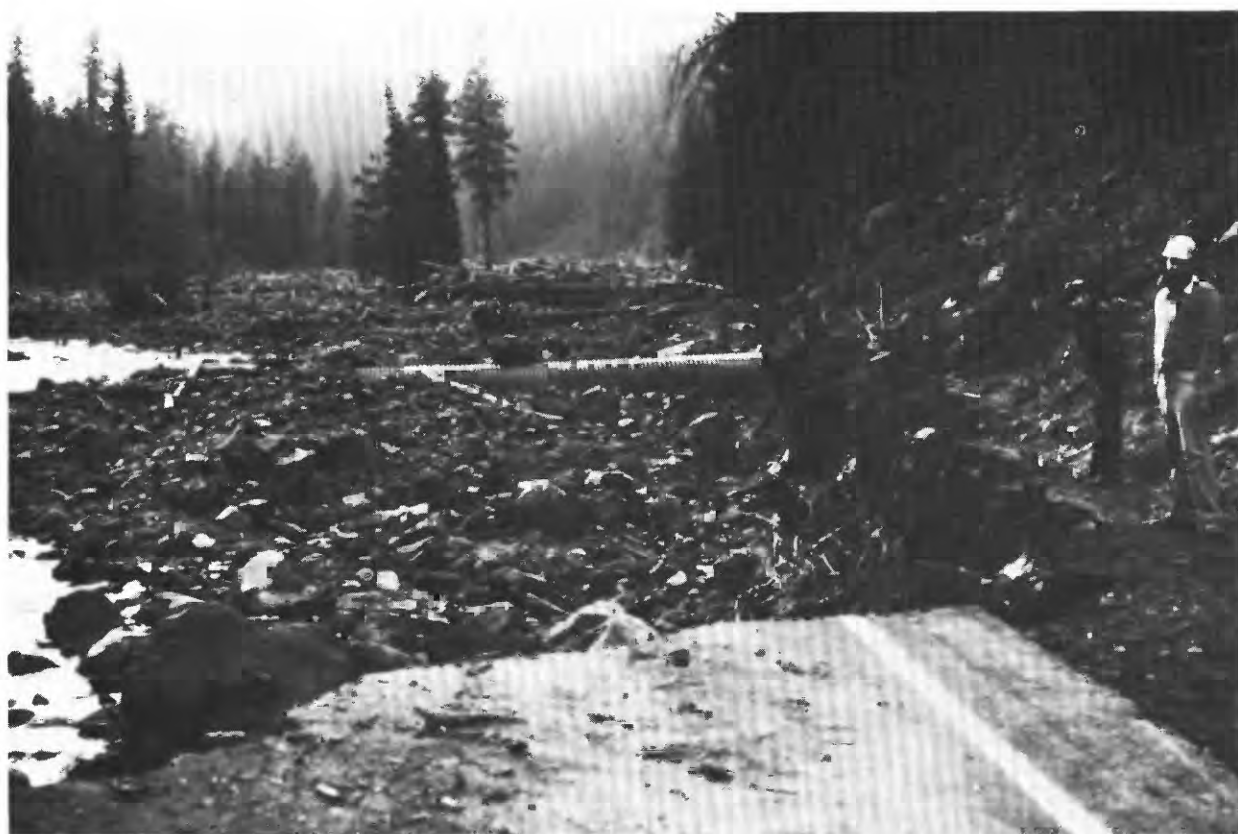
Figure 16. Highway and East Fork Hood River channel impacted by the dam-break flood, approximately 1.5 miles downstream from mouth of Polallie Creek. Photograph courtesy of U.S. Forest Service, December 26, 1980.

The most extensive and visible impact of the Polallie Creek debris flow and subsequent flood was the destruction or damage to the highway, bridges, and parks bordering the East Fork Hood River (fig. 16). The Oregon State Highway Division reported the following damage statistics (Coulter and Terpin, 1981): "1.5 miles of highway completely obliterated, another 1.3 miles of roadway at least 50 percent obliterated, and 2.2 miles damaged to where all surfacing must be replaced. Only 1.6 miles of the

6.6-mile segment remains relatively intact. Costs to restore the highway to current standards with adequate protection from future floods is estimated to cost \$12.1 million."

In addition to the 5 mi of Oregon Highway 35 that were destroyed, the approaches or footings to three bridges were badly damaged. The main supply pipeline of the Crystal Springs Water District, which serves 1,400 residences on the east side of the Hood River valley, had approximately 600 ft of its water main washed away and another 3,500 ft damaged badly enough to require replacement. Costs to repair the pipeline damage were approximately \$1 million.

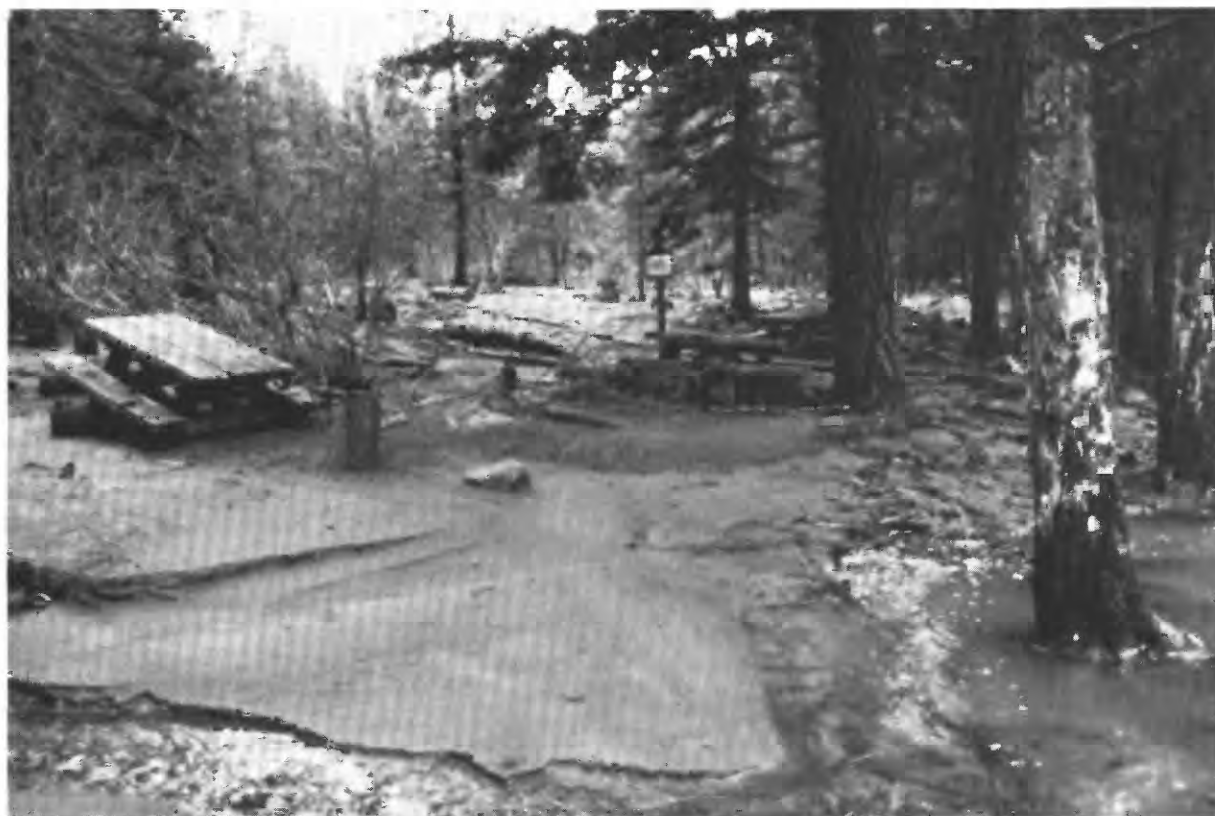
Figure 17. Polallie Campground partially inundated by fine-grained deposits from the recessional phase of the debris flow. Photograph taken December 26, 1980.

The grimmest reminder of the catastrophic effects of such debris flows is the loss of life. One man was killed by the Polallie debris flow. His trailer was parked in Polallie campground at the confluence with the East Fork Hood River. The trailer was overrun and completely demolished when the debris flow burst out of Pollalie Creek canyon. The old section of Polallie campground was almost completely destroyed (fig. 17), and the new section and Dimmick State Park, 9 mi downstream, were severely damaged by deposits of sand and cobbles left after flood waters receded. Serious consideration should be given to the possibility of debris-flow hazards when locating campgrounds and parks. A debris fan at the
